## SPACE STATION SOLAR ARRAY JOINT REPAIR

**ABSTRACT:** In Oct 2007 the International Space Station (ISS) crew noticed a vibrating camera in the vicinity of Starboard Solar Alpha Rotary Joint (SARJ). It had less than 5 months of run time when the anomaly was observed. This ~3.2 meter diameter bearing joint supports solar arrays that power the station critical to its operation. The crew performed an EVA to identify what was causing the vibration. It was discovered that one of the 3 bearing tracks of this unconventional bearing had significant spalling damage. This paper discusses the SARJ's unique bearing design and the vulnerability in its design leading to the observed anomaly. The design of a SARJ vacuum test rig is also described along with the results of a life test that validated the proposed repair should extend the life of the SARJ a minimum of 18 years on-orbit.

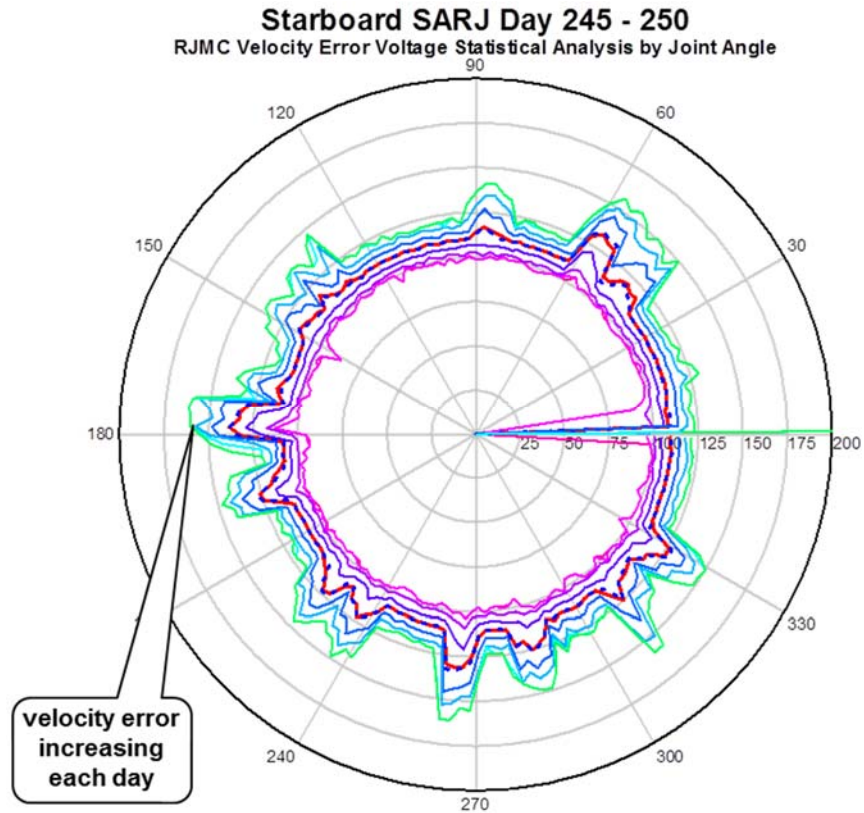
**SARJ Starboard Vibration Anomaly:** The ISS crew noticed vibration on one of the monitoring cameras in the vicinity of Starboard SARJ on 22 Oct 2007. The starboard SARJ had been operating less than 5 months when this anomaly was observed. Velocity traces from the controller showed a significant increase in servo errors after 5 days of monitoring (Figure 4).

Figure 4: Velocity error trace showed increasing servo errors at several clock positions

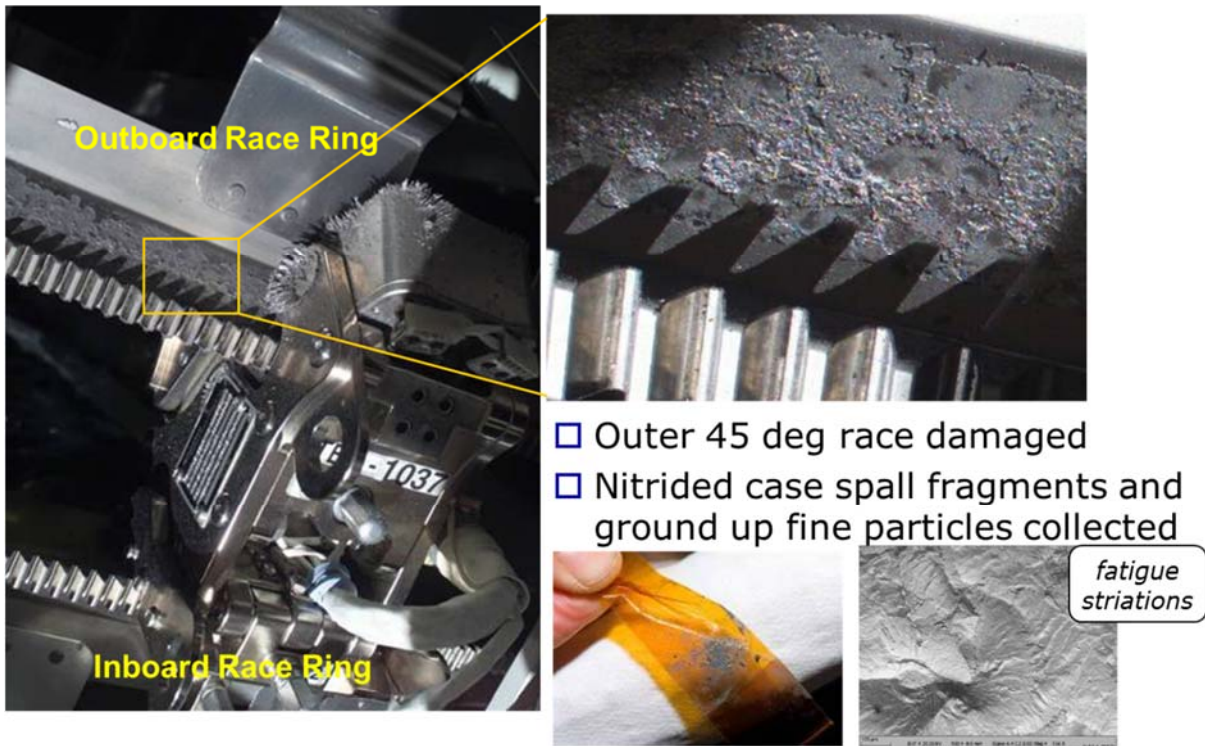
The crew was sent out to investigate the SARJ. They found significant race damage on outer 45 deg track (Figures 5). The nitrided case had spalled creating many nitrided case fragments (Figure 6). The increased torque and vibration resulted from the preloaded rollers rolling over the damaged track surface covered with these residual case fragments. However the inner 45 deg and datum A races remained undamaged (Figure 3). Also the Port SARJ races were still in good condition after 14 months of operation at the time of the inspection [1].

Figure 5: Damaged On-orbit Starboard SARJ 45 deg race ring track

Fortunately analysis indicated that lubricating the damaged and undamaged tracks with grease would likely lower the equivalent friction coefficient below the roller tipping threshold of less than  $\sim 0.4$  [2]. Clearly this would be far easier and less risky repair to implement if it could be demonstrated that greasing the races would be effective in extending SARJ track life. So planning was begun on a high fidelity test rig with the goal of demonstrating that grease lubrication would prevent additional damage to the Starboard SARJ. The goal was to prove that the SARJ could safely run another 18

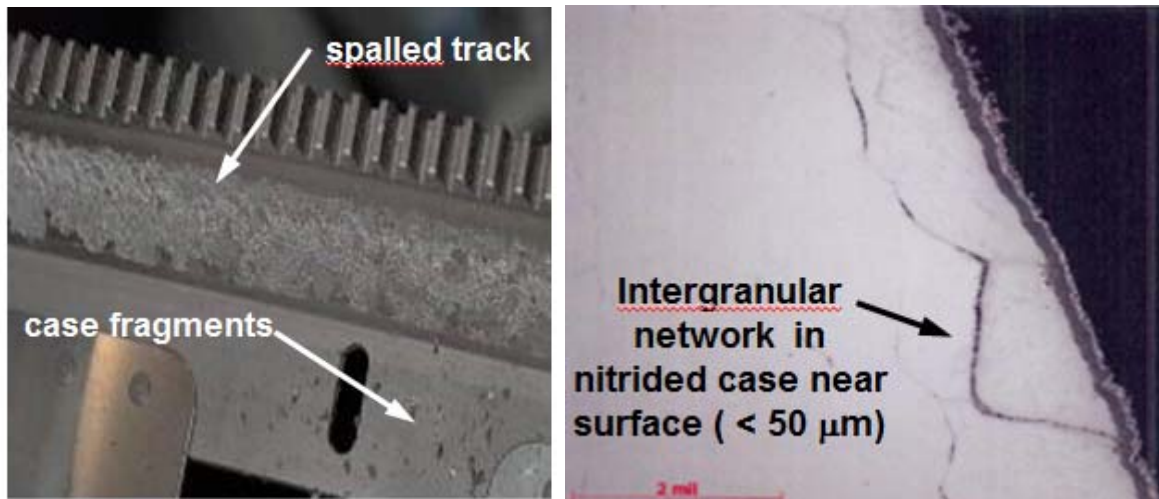
**Figure 6: Close up of spalled track and cross-section through case showing intergranular separations (voids)**

As shown in Figure 7 the small misalignment (a.k.a. mistracking) caused a side slip velocity to be generated relative to the race rotation velocity vector. This side slip velocity in turn generated an axial contact force that caused the roller to tip about the camber pivot axis. To react this moment load, the load distribution across the roller width shifted to the outboard edge generating high roller edge contact stresses ( $> 5$  GPa maximum Hertz stress). The high contact edge stress coupled with intergranular networking (crack-like separations) just below the race surface ( $< 50$  microns) initiated the spalling observed on the damaged race. (Figure 6). [2-5].

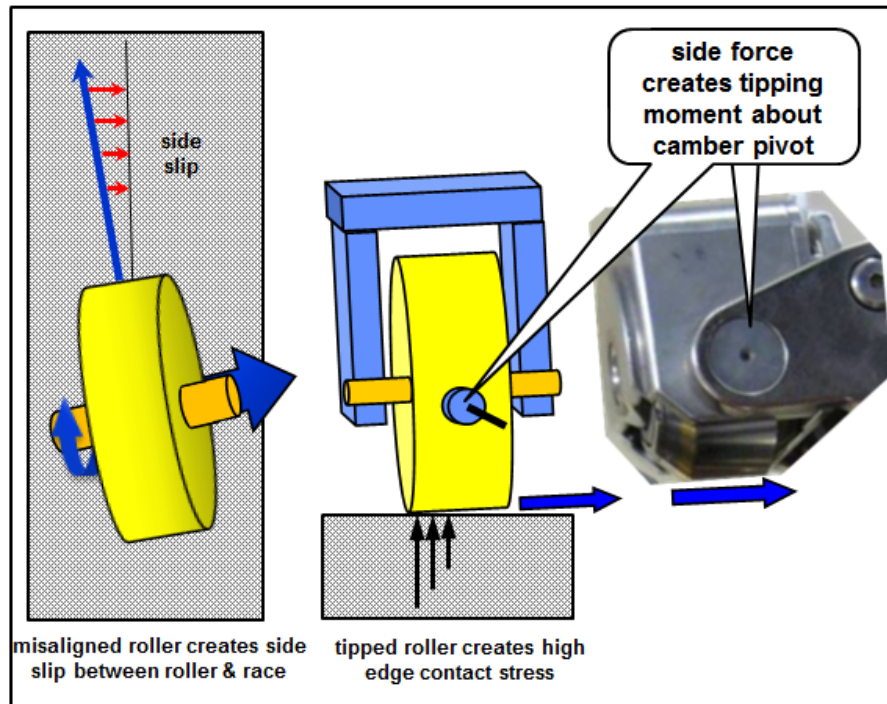
**Root Cause:** A Government –Industry team was formed to determine root cause. It was determined that the damage to the race was caused by an unexpected sequence of events. Although the rollers were aligned with the race track with in a small degree of error (within  $\pm 1$  degree) it was discovered that even a slight misalignment ( $< 0.5$  deg) could cause the roller to pivot about the camber pivot axis. This would cause high roller edge loading because of the high surface friction forces from inadequate lubrication .

**Figure 7: Tipping mechanism created by slight misalignment coupled with high contact friction which causes the roller to tip about pivot axis**

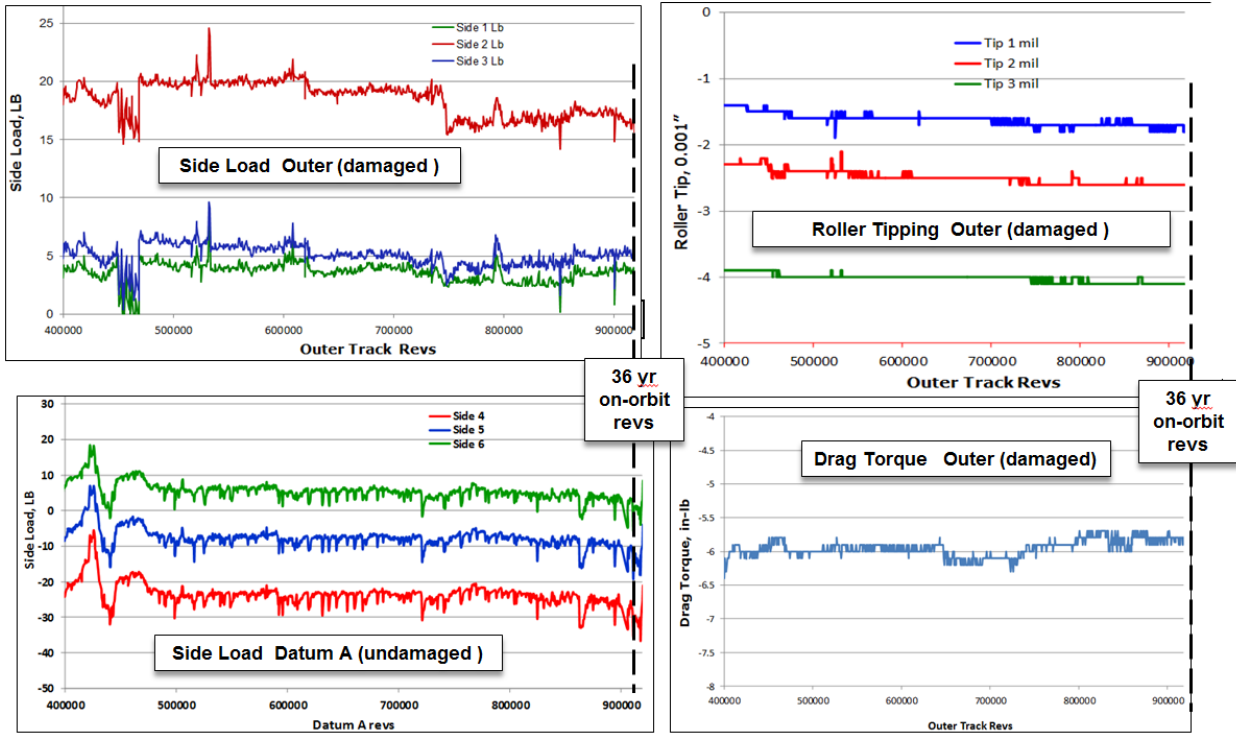
As shown in Figure 10, the individual roller side loads of both damaged and undamaged tracks remained relatively constant throughout the test. The drag torque on the outer track also remained relatively constant. The relatively stable behavior of these health indicators confirms that grease degradation was relative minor over the life test. The only exception was when the rig was temporally stopped because of a test rig problem. These interruptions caused the baseline to shift slightly due to zero shifts in the load cell that were related to changes in ambient temperature changes. Algorithms were developed to help calibrate out these temperature variations. However the discontinuities still were present but did not influence the health trending taken between these events.

Another important parameter that was important to trend was roller tipping. As mentioned previously it was determined that roller mistracking coupled with high surface friction from dry roller contact was the root cause of the SARJ failure. The high contact stress due to roller edge loading as a result of mistracking caused the roller to spall the nitride case. During the test a LVDT was mounted to the spider to measure the degree of tilting of the trundle roller cradle assembly. The tilting angle will increase if side load traction were to increase. The tilting angle also remained relatively constant throughout the test. This is essentially an independent confirmation that the roller contact friction levels also remained stable during the test (Figure 10).

**Figure 10 Test results showed relatively steady contact friction levels, roller tipping and drag torque throughout life test**

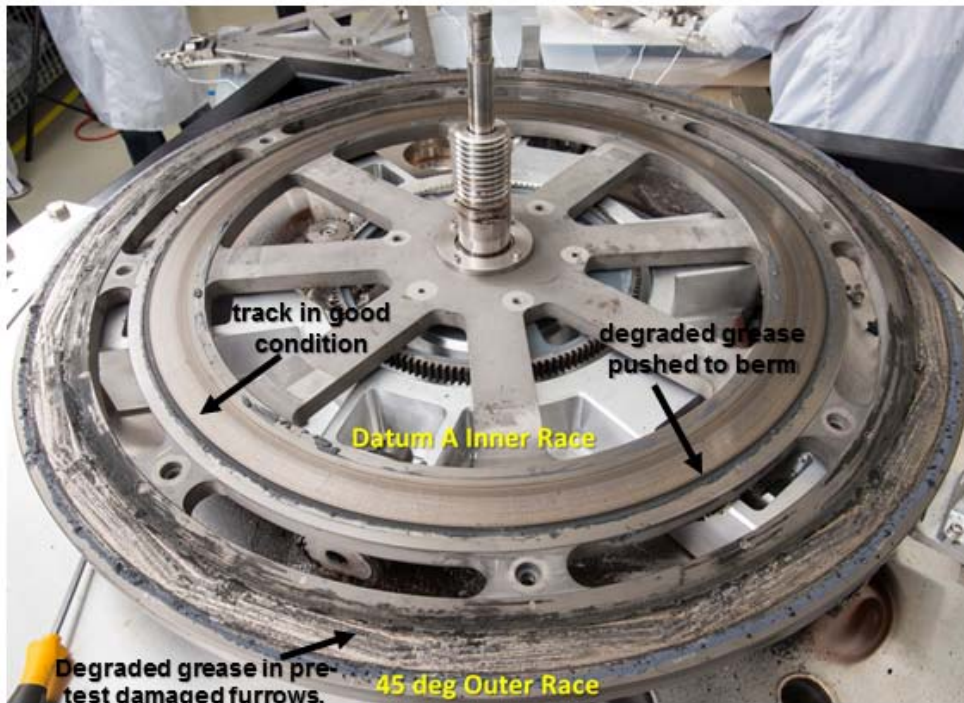
At the end of the test the two test tracks were examined for damage and lubrication degradation (see Figure 11). The initially undamaged inner track showed minor pitting (spalling) of surface. The track was still in good condition. The outer berm was still in place and was evidently re-supplying the rolling track with a slight oil film at the conclusion of the test.

The outer track show a modest degree of additional wear on the raised surfaces relative to the intentional pre-test damage created to represent starboard SARJ. Degraded grease was retained in the man-made furrows in the track. Also berms were healthy on both sides.

Figure 11 Track appearance at end of test
